# **Historical Scorecard**

# **PQP Failures**

# **PQP Failures Continued**

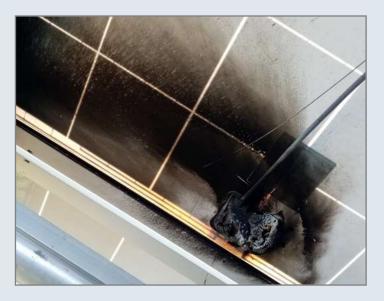
The image above shows a PV module at the project site with a junction box that melted due to electrical arcing.

A 50 MW PV plant in Africa built in 2013 began to exhibit serious failures from poor soldering and failed diodes after just five years of operation.

Over 3,000 modules were affected by poor soldering in the junction box, which led to catastrophic junction box failures due to electrical arcing.

In one case, the molten plastic from the melted junction box started a brush fire in the dried grasses below the modules.

The asset owner's warranty claim is being resolved at the manufacturer's discretion, so field repairs of the affected modules have been prioritized over full replacement.
