2020 Study results

Inspection observations based on 3GW of fields:

Backsheet field study key findings

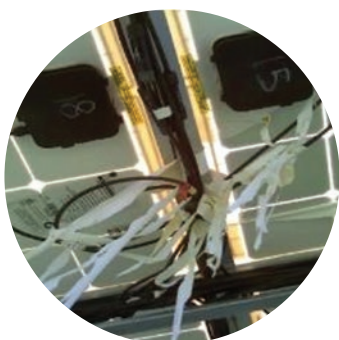
5 years
Eastern Canada

There have been observed many examples of widespread backsheet through-cracks.

- These failures are prevalent along busbar ribbons, but with continued weathering can extend to cell gaps and other regions.
- Arcing and shorts often lead to localized burn-through and sometimes full module fires.
- Reported inverter tripping and ground faults.
