2020 Study results

Inspection observations based on 3GW of fields:

Backsheet field study key findings

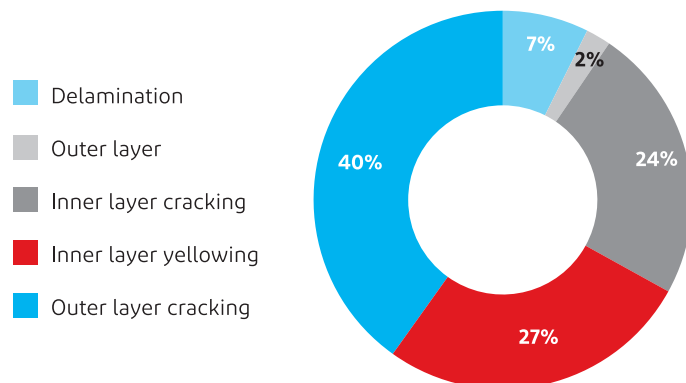
Backsheet defects by degradation mode

- Total module defects: 30%
- Total backsheet defects: 16%
- Total cell/interconnect defects: 14%
- Cracking comprises 64% of all backsheet defects

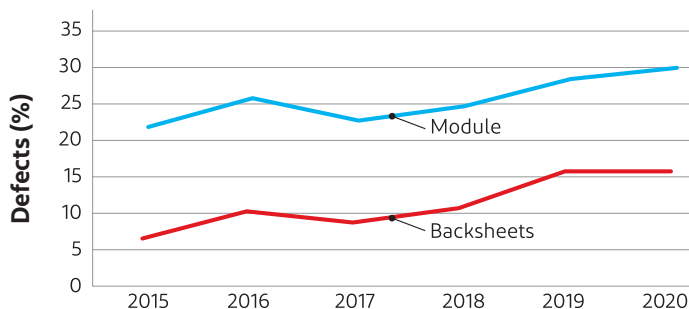
Defect trends

- Rapid increase in cracking in polyvinylidene fluoride (PVDF) backsheets
- Cracking of inner layers
- Delamination in double glass modules
- The overall PVDF outer layer cracking rate increased more than 3x
- The overall inner layer cracking rate tripled

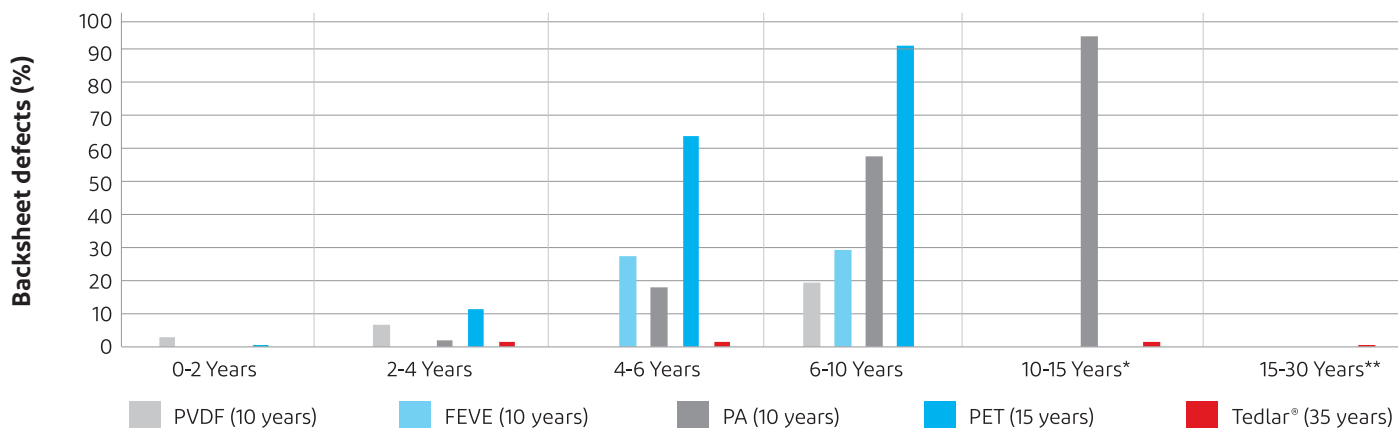
Defect rates in PVDF, FEVE, PA, PET and Tedlar® backsheets

DuPont™ Tedlar® polyvinyl fluoride (PVF) film-based backsheet maintains the lowest defect rates—even after 35 years in the field.

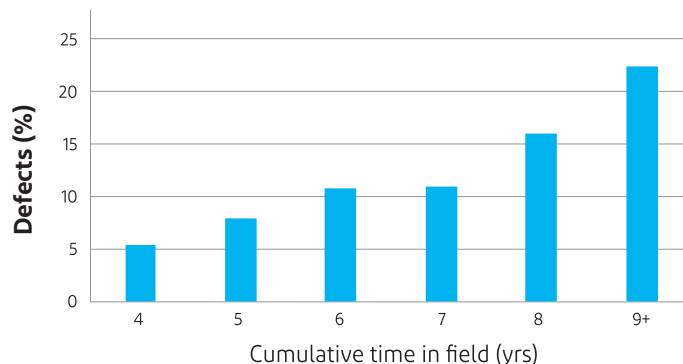
PVDF backsheet cracking defect rate

There has been observed nearly a four-fold cumulative increase in PVDF outer-layer cracking defect rates, from 5% to 23% between year 4 and year 9 after installation.
